Inspection Report

Minerals Regulatory Program

Mine Name: Clark #1/Emeryide

Permit number: S/015/053

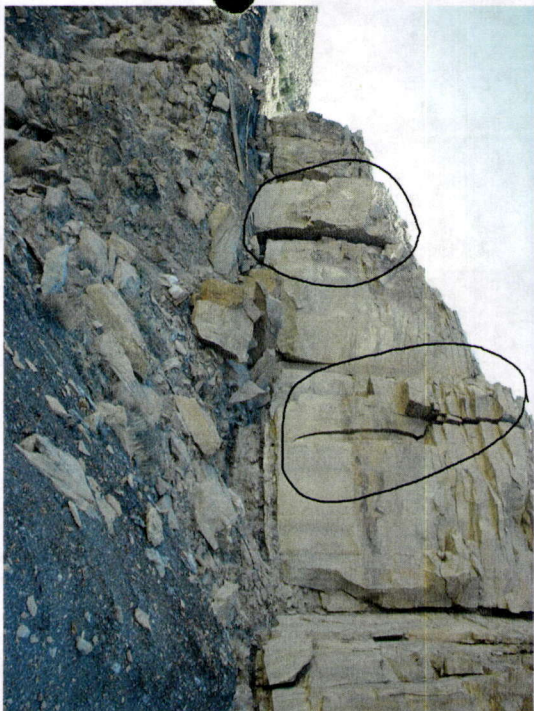
In the report for the September 26, 2002, inspection, I made a few comments about maintenance that was needed, and some of this maintenance still needs to be done. I am particularly concerned about some large sandstone blocks that appear to be on the verge of falling (Photos 1 and 2). I believe they would fall to the Miller Canyon Road below the mine, and while this is not a heavily traveled road, there is definitely some danger to the public. The operator needs to investigate the possibility of intentionally failing these rocks to reduce the potential danger.

Photo 1. This picture was taken in 2002 by, I believe, Jeff McKenzie of the BLM. It shows large sandstone blocks that appear to be on the verge of falling.

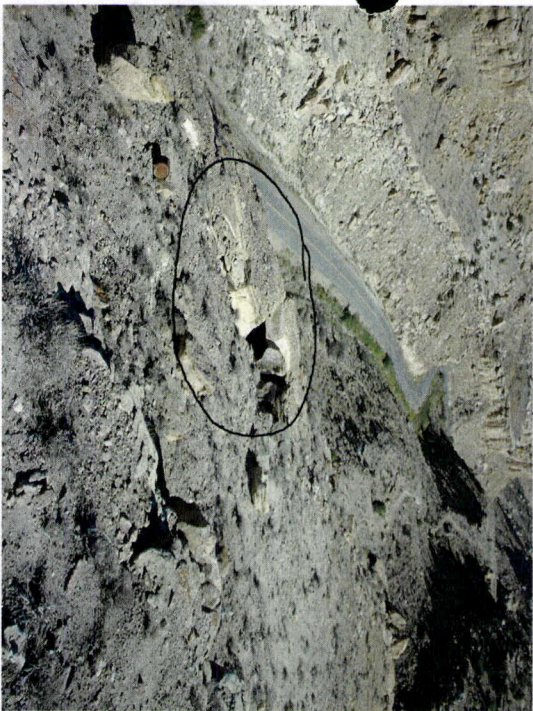
Photo 2. Also taken in 2002. Note how pieces of rock in the circled area have separated from the bedrock.

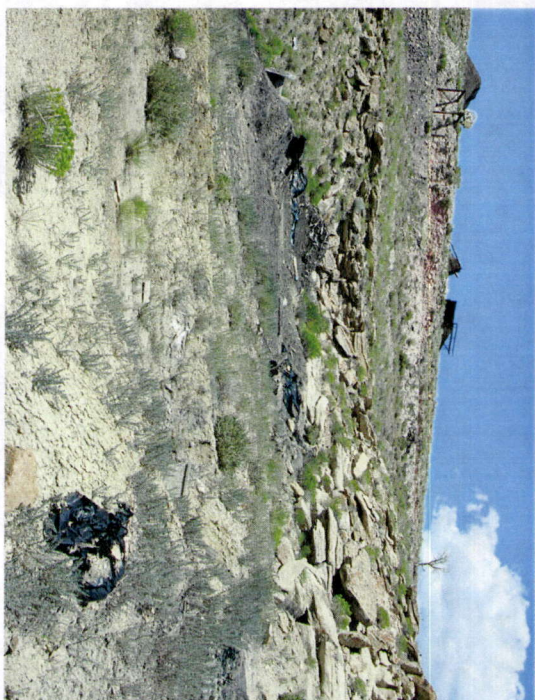
There is some trash that needs to be cleaned up, including some brattice cloth and some mine waste or product that appears to have been in plastic bags (Photo 3).

Photo 3. An area with what appears to be product or mine waste that was in plastic garbage bags. This needs to be cleaned up.

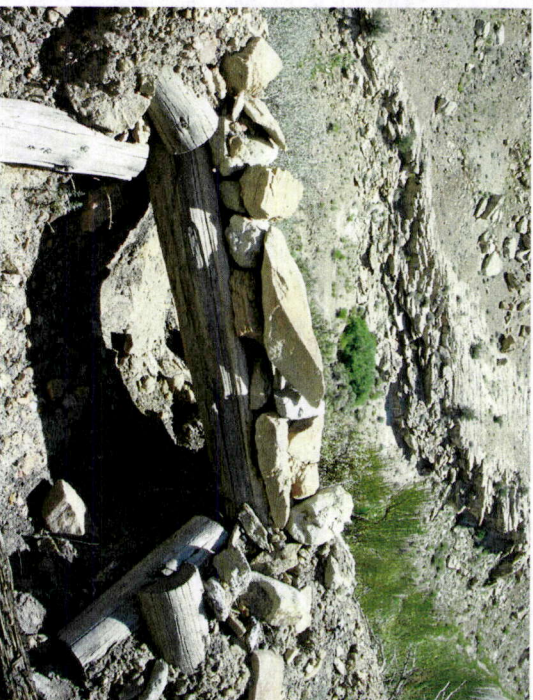
There is a berm along the edge of the mine pad, and Photo 4 shows a breach where drainage would be allowed to go down the pad outslope. I suggest that a notched silt fence be installed at this location to treat the runoff.

Photo 4. I suggest that a notched silt fence be installed in front of this breach in the berm.
